## 4.0 RESULTS

### 4.1 Test Area A

S.R. 54 IMPROVEMENTS  
SOUND CHURCH ROAD TO KEENWICK ROAD  
BALTIMORE HUNDRED  
SUSSEX COUNTY

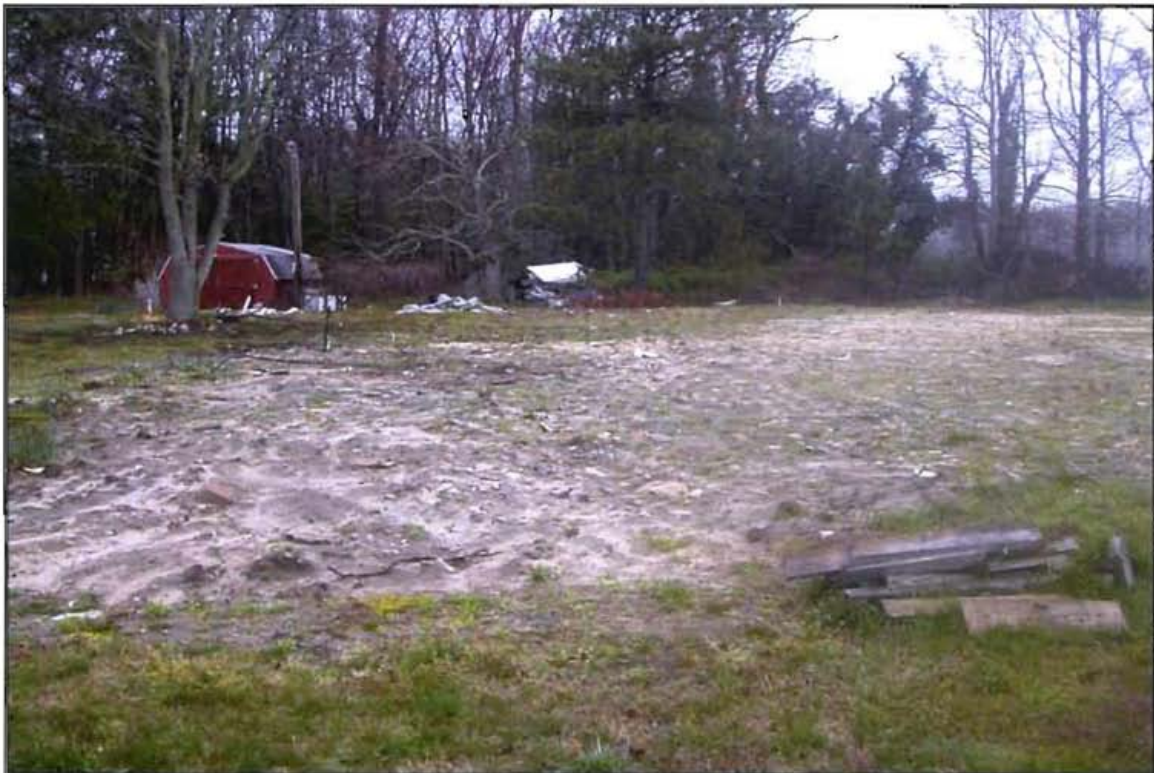
*Photograph 6. View of former house (CRS# S-10028) location in Test Area A, facing north.  
Note ground disturbance.*

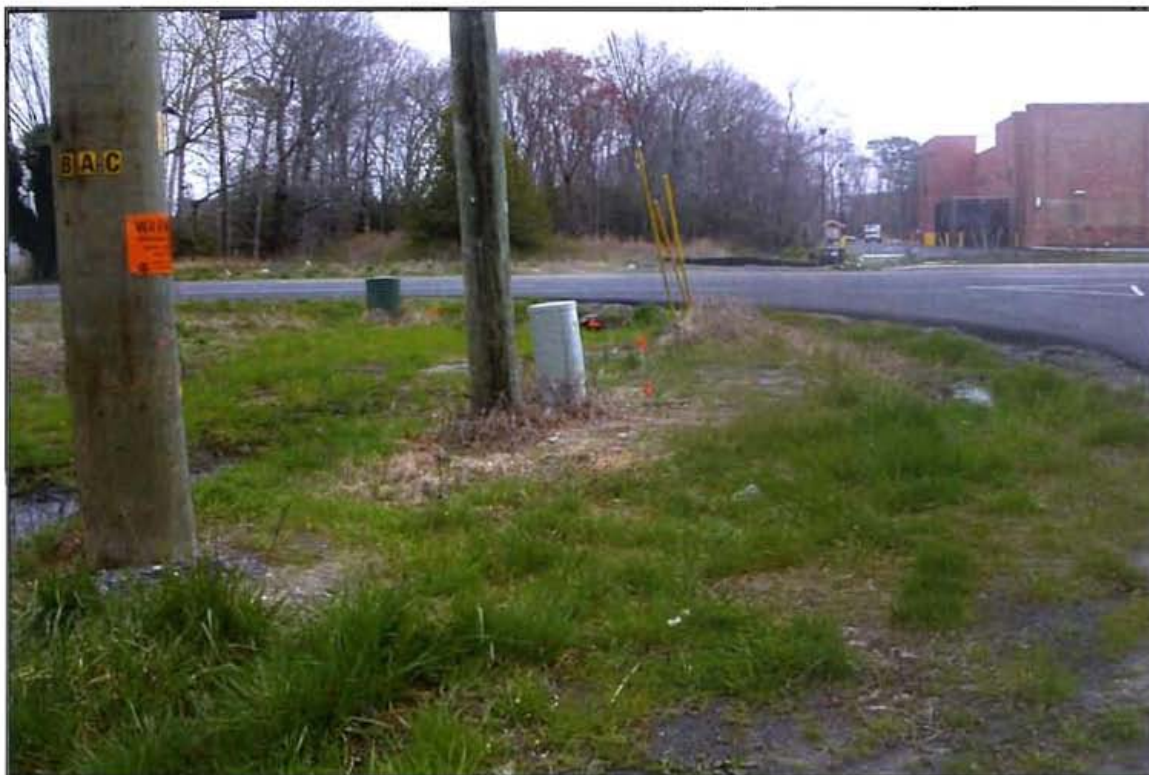
*Photograph 10. View of utility disturbance in Test Area A near corner of Old Mill Bridge Road and S.R. 54, facing south.*

Test Area A is located immediately east of Old Mill Bridge Road and north of S.R. 54, and is comprised of the proposed locations of SWM Areas 1 and 2. Test Area A is irregular in shape and approximately 0.07 ha (2.64 ac) in size. Of this acreage, approximately 0.21 ha (0.51 ac) are disturbed or paved. At the time of the archaeological survey, portions of the test area were wooded with moderate undergrowth, old cornfield, and/or short grasses (Photographs 1, 2, and 3). A dirt/grass lane parallels S.R. 54 from Old Mill Bridge Road eastward into the interior of the test area where the house once stood. It most likely served as a secondary driveway. In the eastern portion of Test Area A where the house once stood, several gravel and/or dirt lanes, as well as two outbuildings, remnants of a fence line, a drainage ditch, a brush pile, and three dump areas, are present (Photographs 4, 5, 6, 7, 8, and 9). What appears to have served as the primary gravel driveway to the house is west of where the house stood and perpendicular to S.R. 54. It leads to an area between the two remaining outbuildings. The three dump areas located to the rear of the house location surrounding one of the remaining outbuildings were viewed, mapped, and photographed. Materials in the dump areas included wood lattice and decking from a pool, car and appliance parts and several trash bags with unknown contents. No materials were collected from these dump areas. These features appear to be recent and are most likely the result of some intermittent dumping of large items during the occupation of the house and clearing during the razing of the house (CRS # S-10028), which once stood on the property. Based on the mid-twentieth century age of the house, dumps or sheet middens used for everyday garbage disposal would not be expected. Buried and above-ground utilities are also present in Test Area A (Photographs 10 and 11). Ground surface visibility was less than 30 percent over most of the test area.

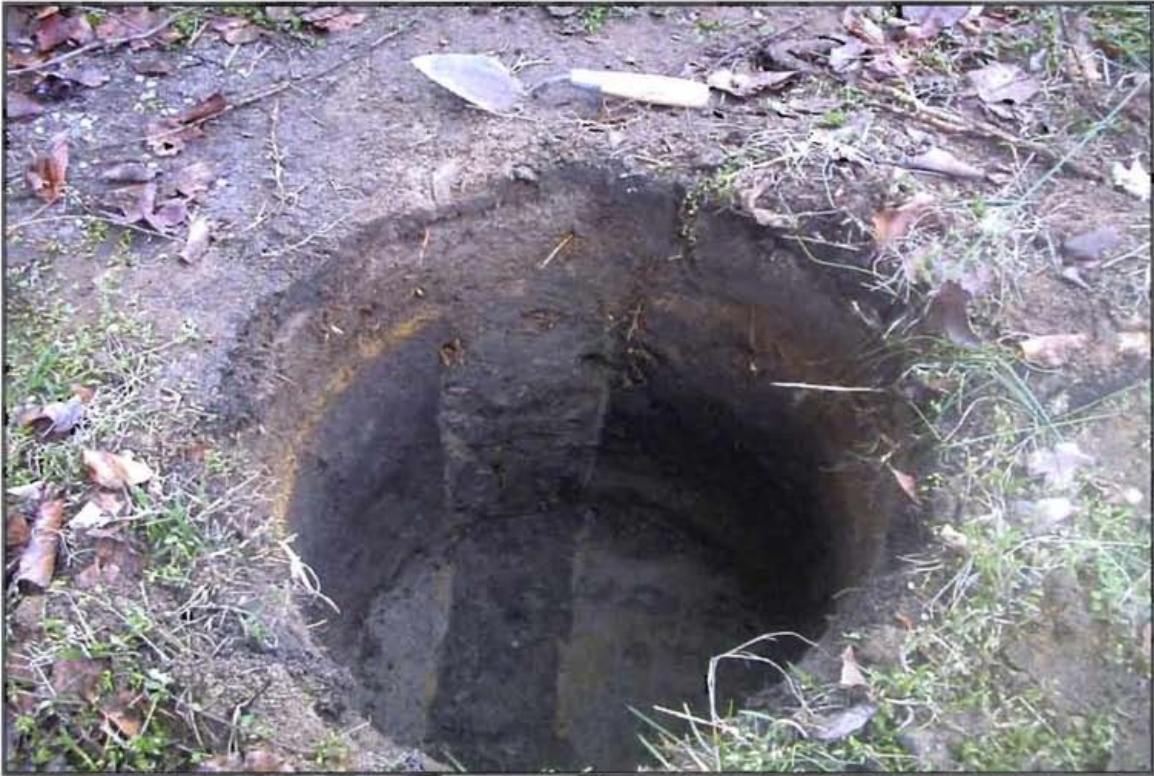
*Photograph 11. View of utility trench disturbance in STP N615 E405 in Test Area A, facing east.*

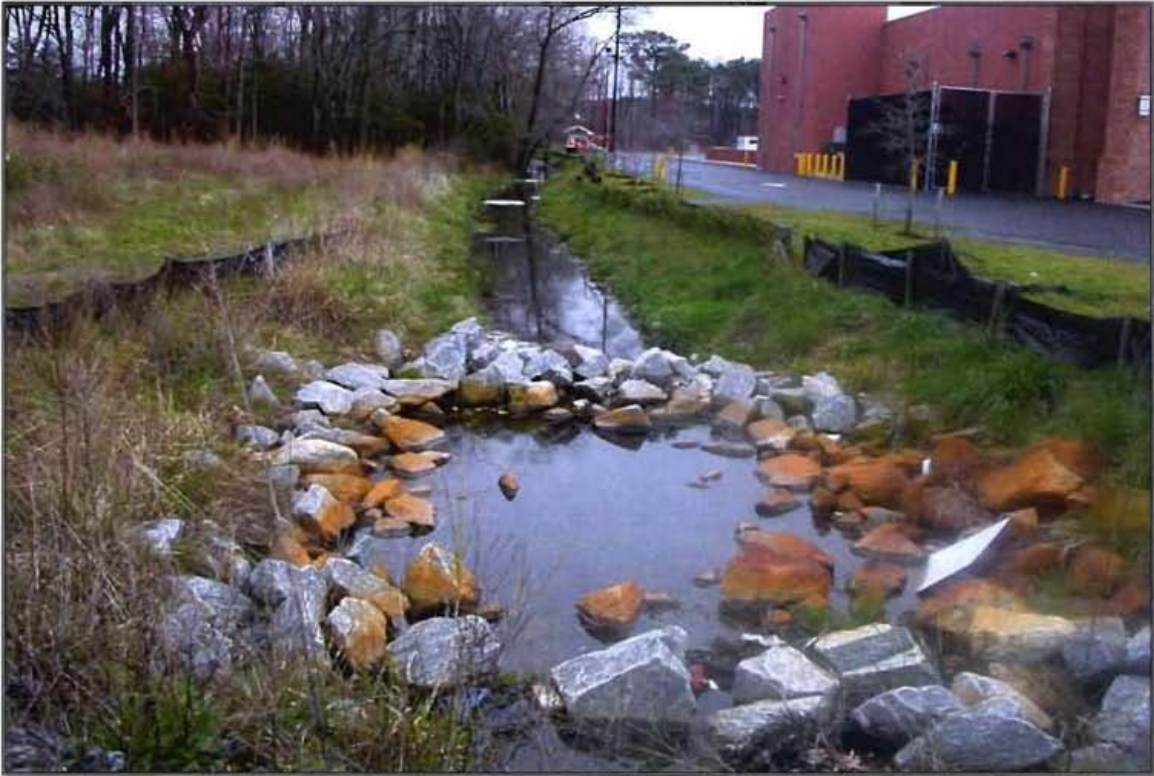
*Photograph 14. View of large drainage ditch, sediment fencing, and commercial disturbance to Test Area B, facing south.*

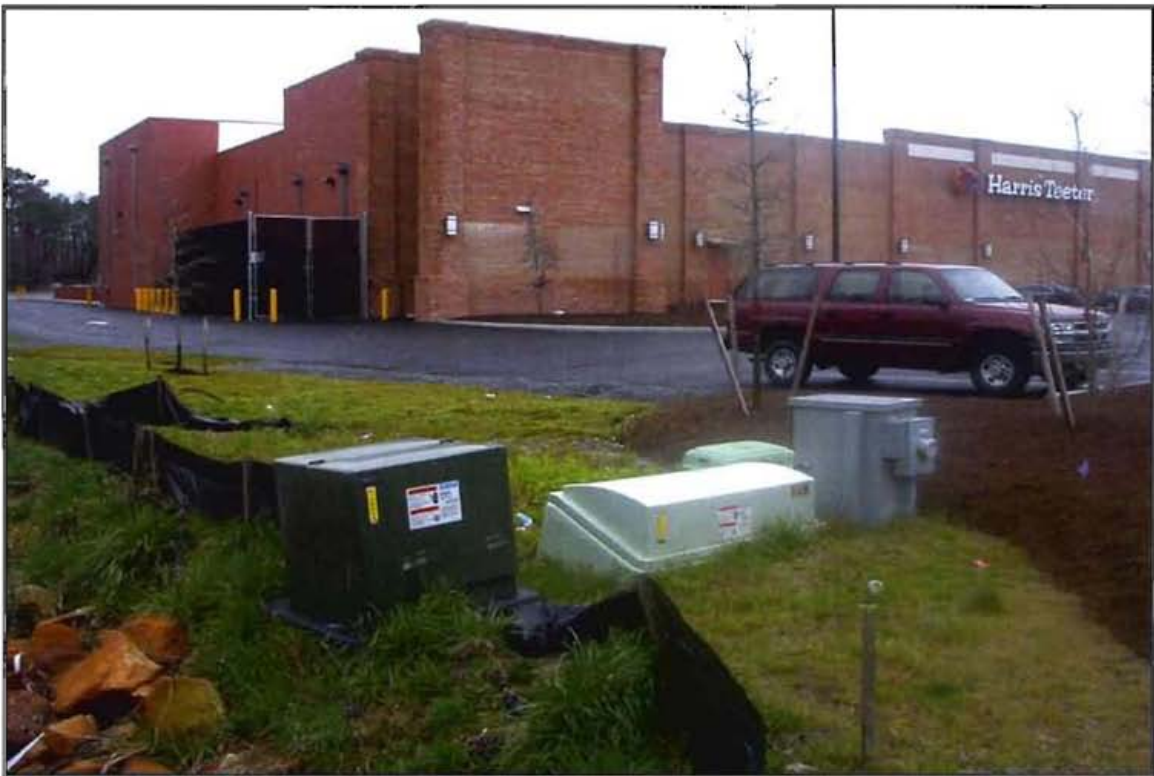
*Photograph 15. View of utility and commercial disturbance in Test Area B, facing southwest.*

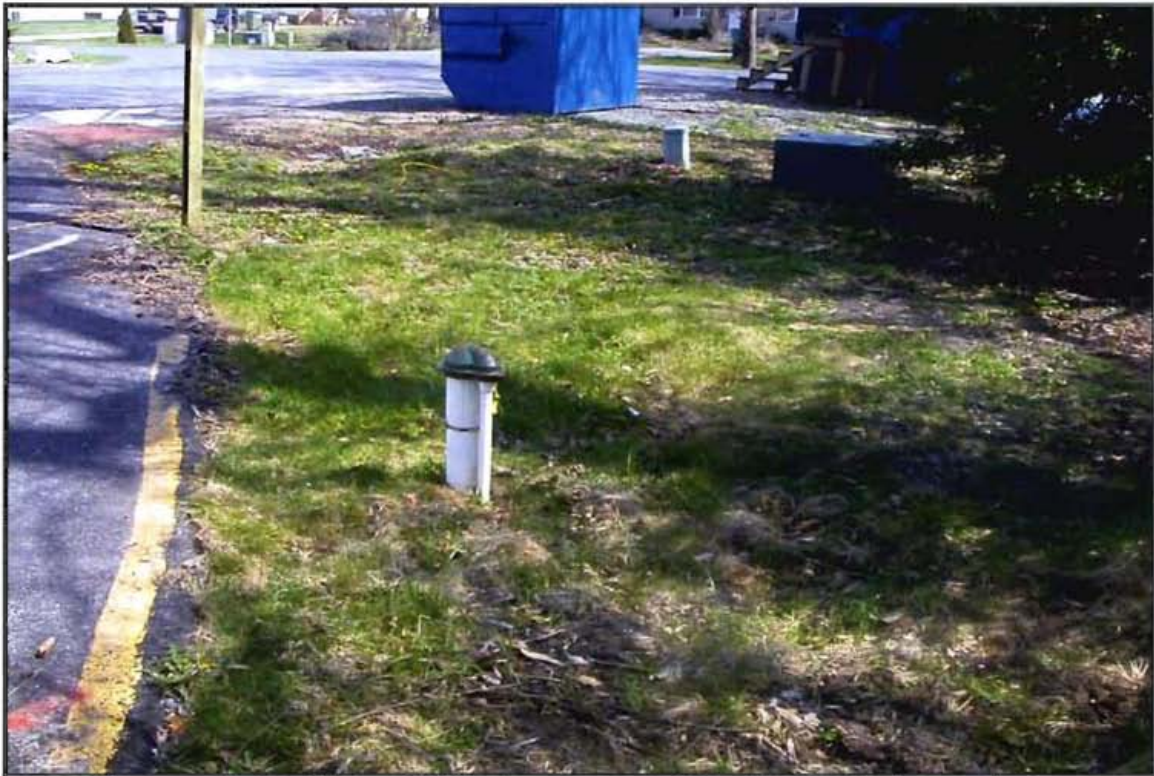
*Photograph 16. View of utility disturbance in Test Area B, facing southeast.*

Test Area B is located immediately south of the intersection of Old Mill Bridge Road with S.R. 54, and is comprised of the proposed locations of SWM Areas 3 and 4. Test Area B is rectangular in shape and approximately 0.19 ha (0.47 ac) in size. Within Test Area B, approximately 0.06 ha (0.14 ac) are disturbed or paved. At the time of the archaeological survey, most of the test area was covered by scrub vegetation, with sporadic trees and gravel (Photographs 12 and 13). Test Area B is surrounded by commercial development, and a large drainage ditch and a gravel lane (most likely the driveway of the house which once stood on the property) are present along the western portion of the test area (Photographs 14 and 15). A large gravel patch, most likely associated with the house that once stood on the property, is located in the southwest corner of the test area. Unlike Test Area A, there are no standing structures or dump areas present in Test Area B. Buried and above-ground utilities and erosion control fencing are present in Test Area B (Photographs 16 and 17). Ground visibility was less than 30 percent over most of the test area.

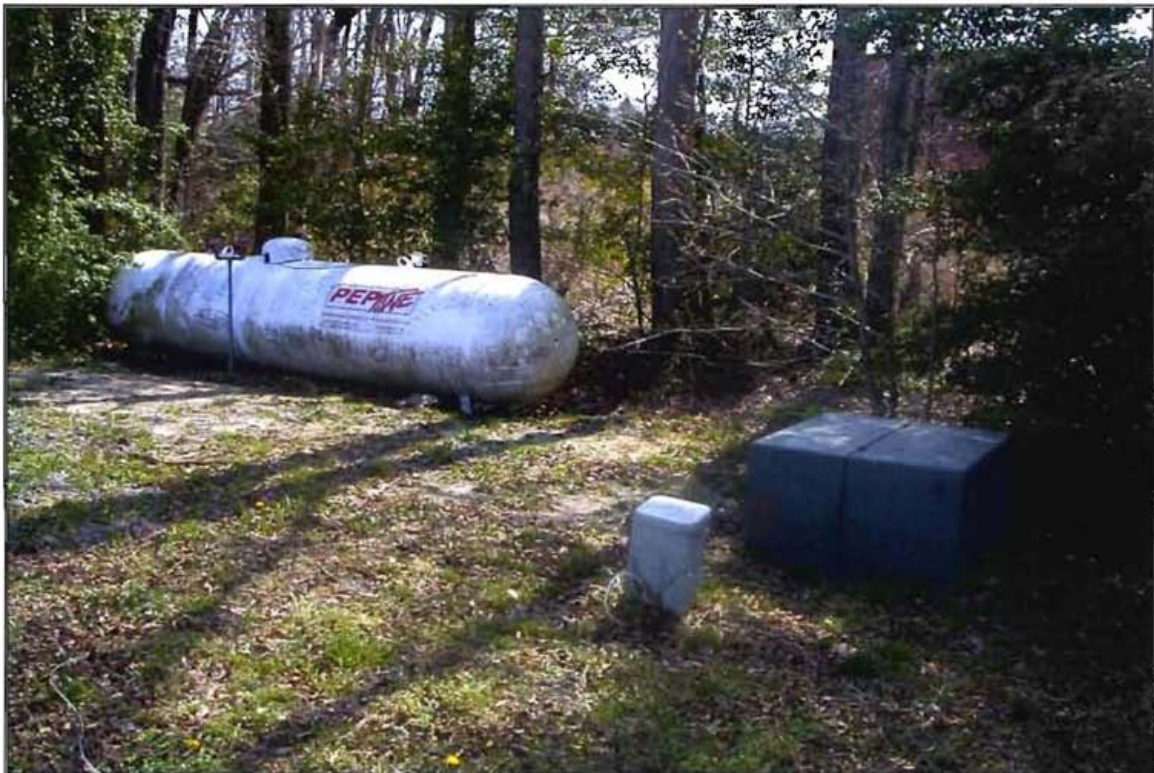
*Photograph 17. View of utility disturbance in Test Area B, facing southwest.*
